## PRELIMINARY CONSERVATION REPORT: INCLUDING CONDITION ASSESSMENT, RECOMMENDATIONS, & COSTS

| <b>Job Number</b> | C280 |
| <b>Owner</b> | Swafield PCC |
| <b>Title</b> | <i>Swafield medieval Rood Screen</i> |

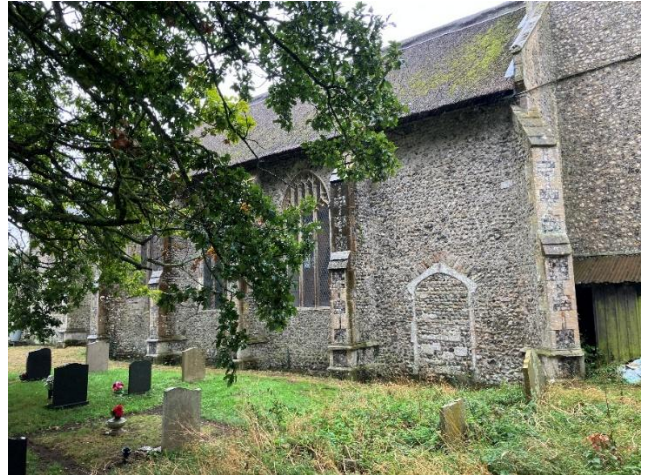
Moss on the thatched roof – ideally would be removed.

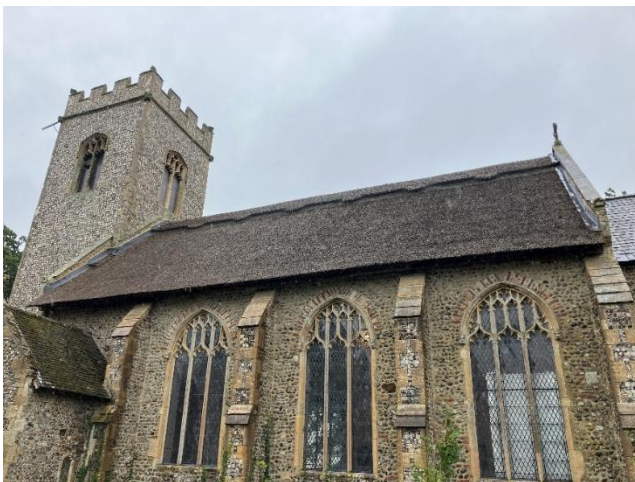
The new thatch on the nave roof is in good condition.

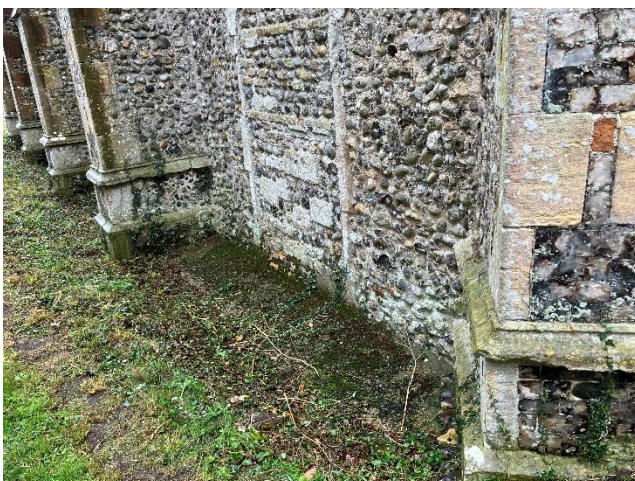
Foliage should be removed from the soakaway.

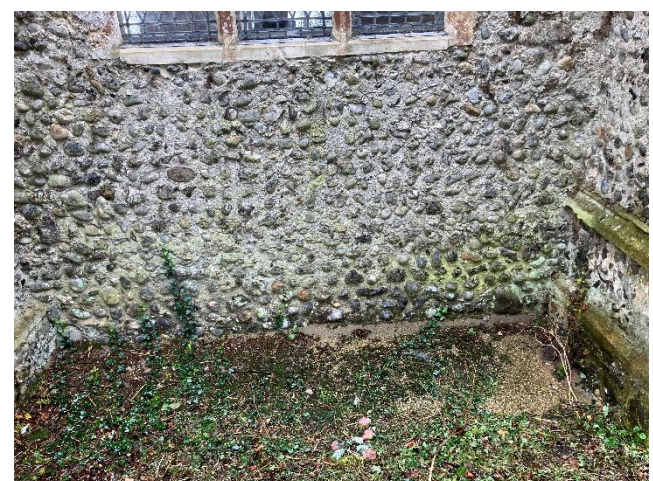
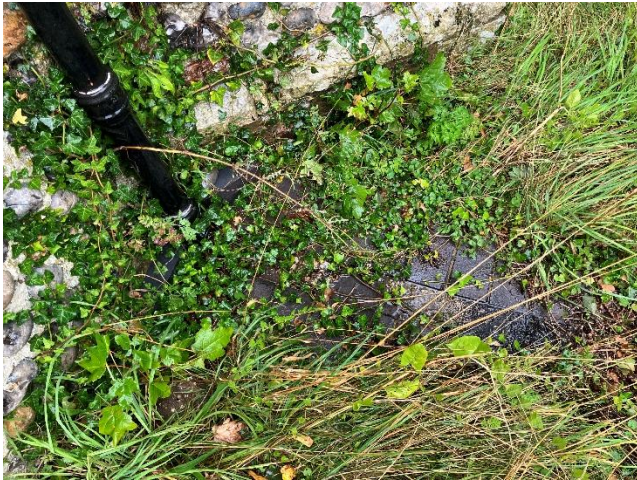
Debris and vegetation should be removed from the blue brick channels and grates and surface water drains.

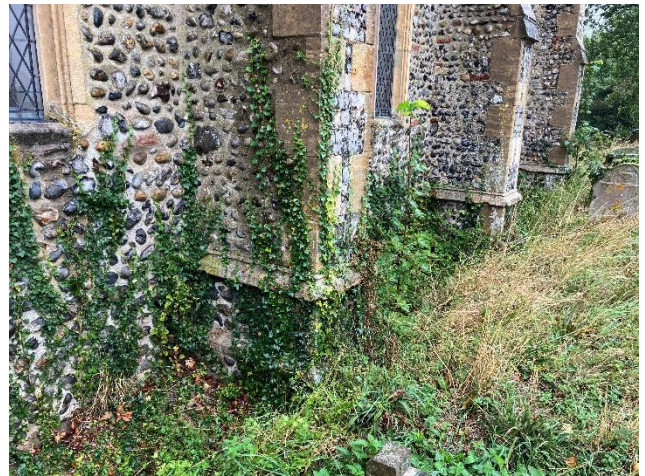
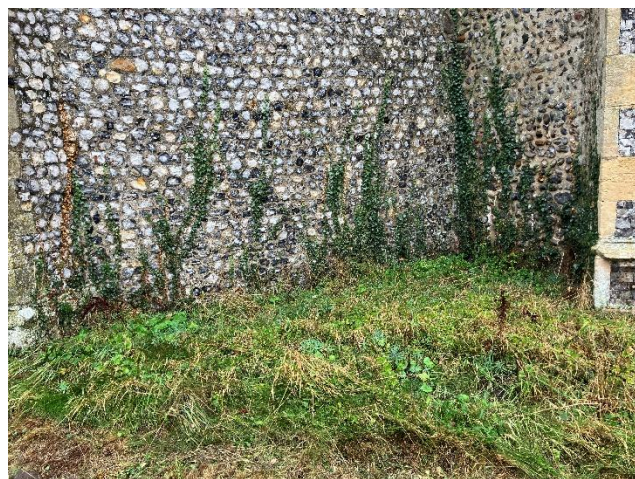
Ivy should be removed to prevent deterioration.

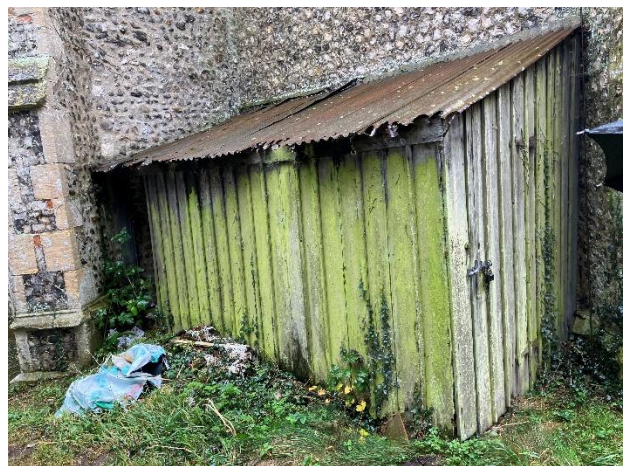
There is a dilapidated shed against the north tower wall. If this is no longer in use it would be recommended to remove the shed and clear the area as it is an obvious source of damp and therefore likely to create/be creating issues within the church.

If no longer required it would be recommended to remove this shed.

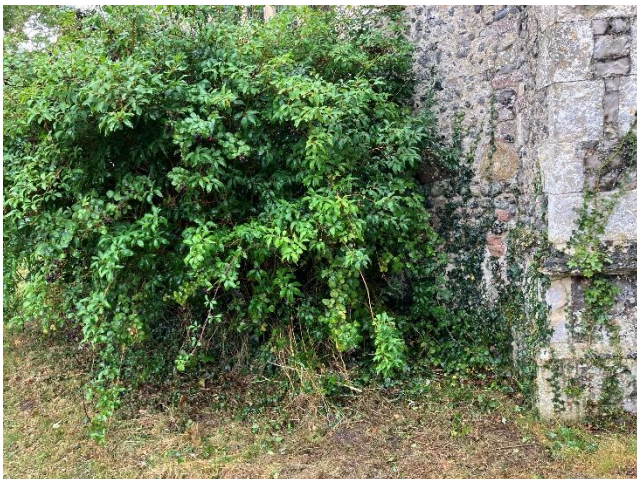
Vegetation and foliage against the east chancel wall should be reduced / removed.

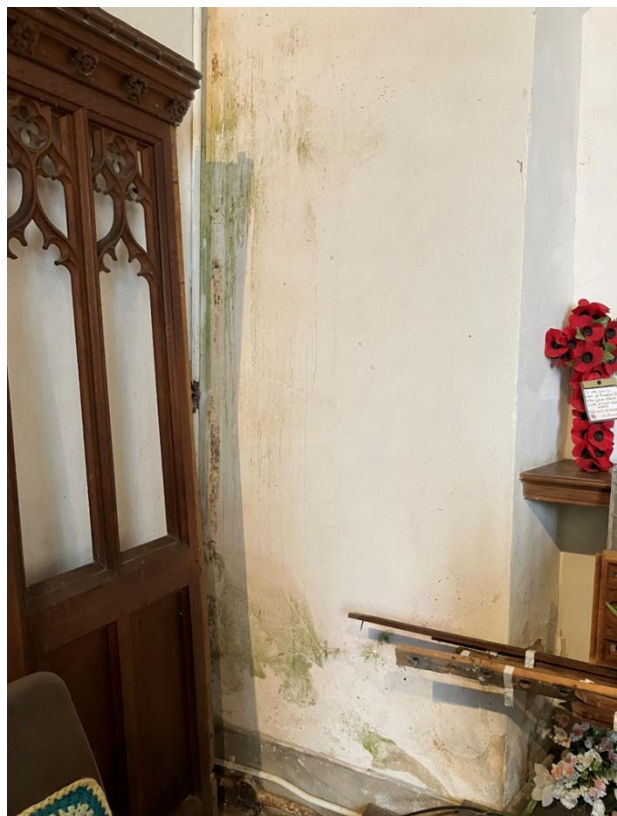
The chancel roof would benefit from some attention to replace cracked and missing slates. The thatched roof appears to be in good condition, however there is a build up of moss on the exterior. It should also be noted that prevailing winds occasionally cause a slight leak in the thatched roof. There was some mould (thus damp) noted on the north-west wall of the nave adjacent to the tower.

Damp noted on wall adjacent to tower.

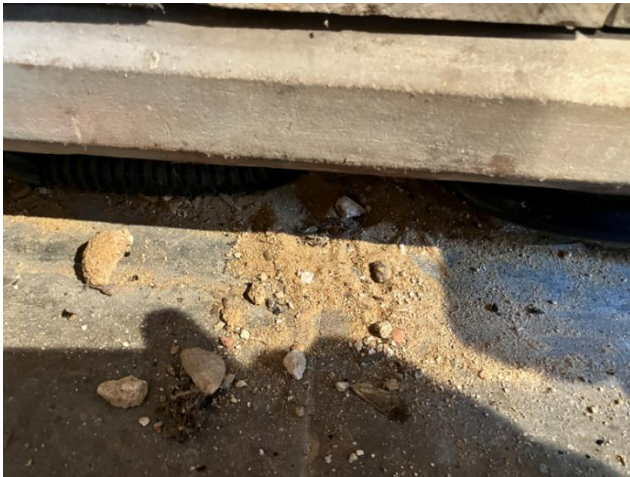
This said, there are no issues of damp around the screen, and the surrounding walls are in a reasonable condition, except a small area of crumbling mortar below the stone step on which the left-hand screen sits. If the screen is to remain in its current location this compromised area would need to be addressed.

Crumbled base; corner on the left below the north screen.

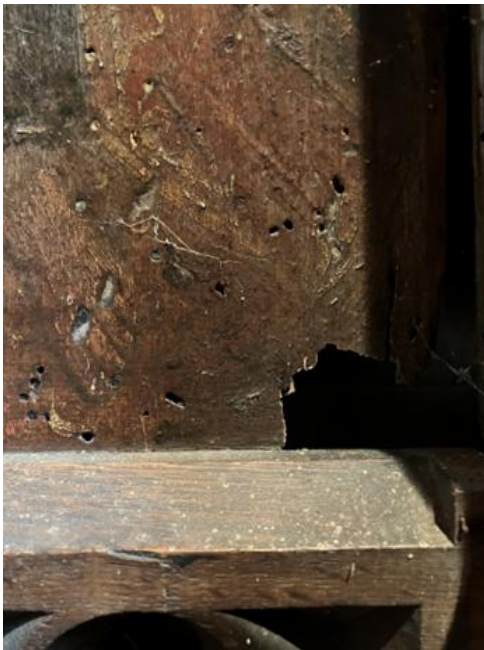
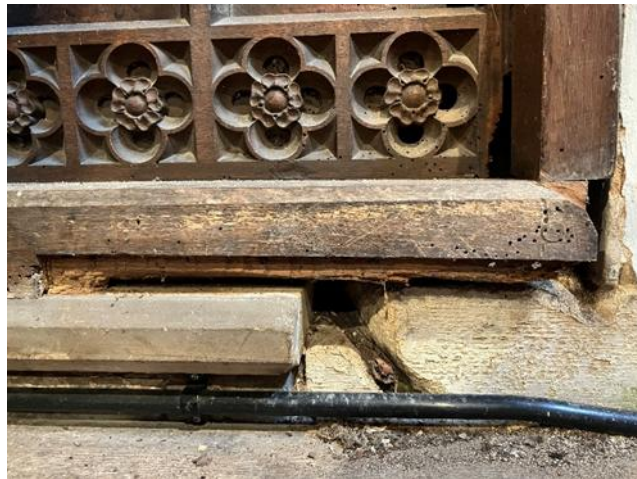
There are two areas of significant damage where structural work will be required, however thankfully the damage is localised. There is damage and loss to the bottom right corner of panel number eight, as well as damage and loss in the wood of the surrounding timber immediately below (see photos). This is historical and appears to be the result of severe woodworm.

- (5) Blanching
- (6) Minor worm damage right edge - **requires woodworm treatment.**
- (7) Old worm bottom left.
- (8) Loose base of pilaster. Old loss of wood in base and panel. Old worm holes. Old cleaning test. In the bottom right corner there is an open join and the surface is fragile due to frass galleries - **requires woodworm treatment, consolidation and stabilisation.**

Damage and loss to the bottom right corner of panel number eight and the surrounding timber immediately below.

- Any areas of wood where the woodworm damage has compromised the structural stability of the wood will be consolidated by injected 10% **Paraloid B72** (diluted in solvent) into the damaged area. This process will be repeated until the damaged area is sufficiently secure.
- The damage to the bottom right corner of panel number eight may require structural work as it is currently extremely fragile and thus susceptible to further damage. The hope is that this area can be

stabilised by consolidation (repeatedly injecting 10% **Paraloid B72** (diluted in solvent) until the damaged area is sufficiently secure). However if this does not provide adequate strength the area may require wooden inserts to discreetly support the original. Creating and attaching the inserts could take a few days and may require the assistance of a carpenter (we have an experienced and trusted carpenter we could call upon).

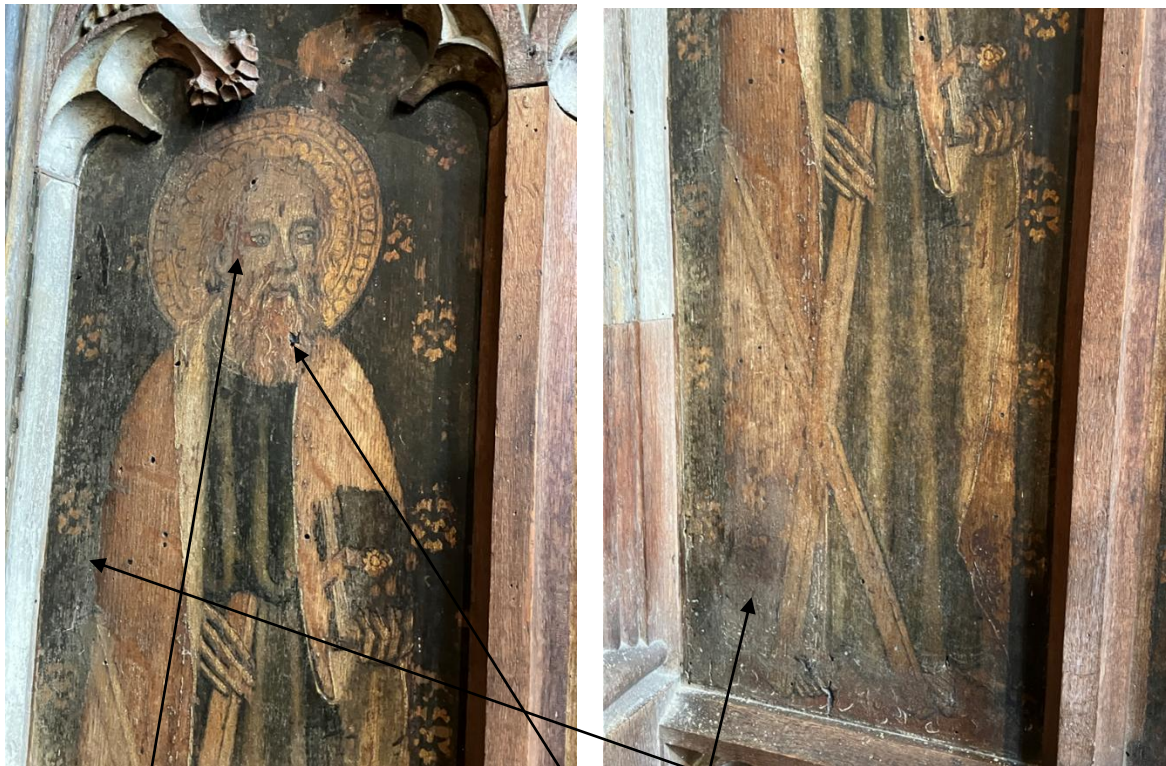
### Panel one

- (1) Some new frass visible in holes on left shoulder of saint. Evidence of old flaking in face and shoulders - not active (appears to have been previously consolidated using wax) - **requires woodworm treatment.**
- (2) Old split running length of painted board, which is stable. Minor old worm bottom and right edges. Old flaking.
- (3) Old worm holes bottom left. Old flaking. Blanching left edge.
- (4) Old worm damage concentrated bottom right. Drip in varnish.

Historic flaking, historic worm and beetle exit holes, blanching of the varnish.

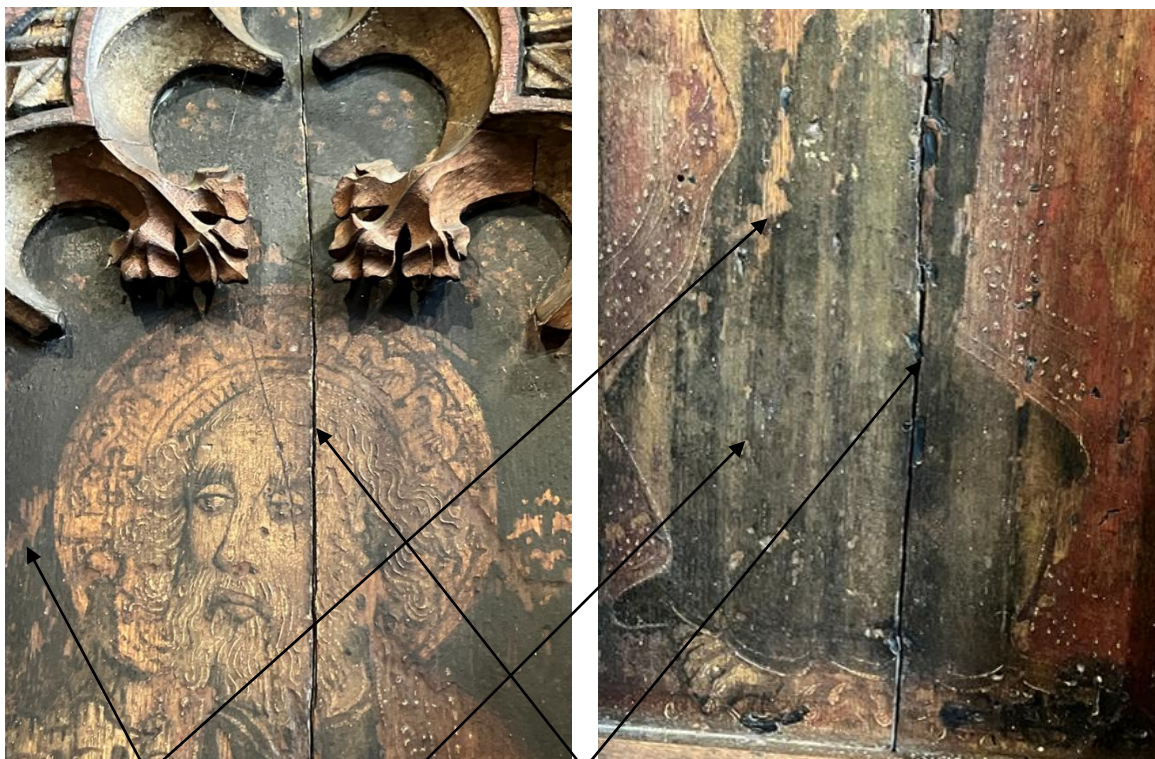
### Panel two

Historic flaking, blanching of the varnish, old split running length of board.

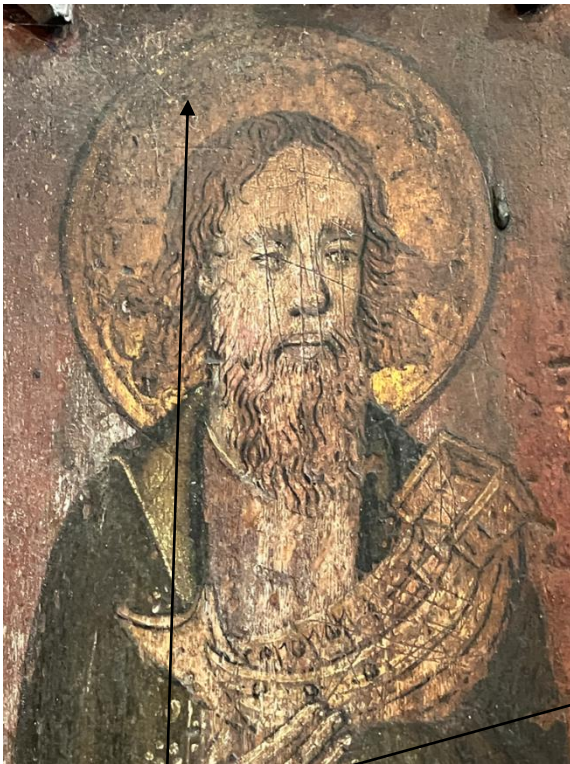
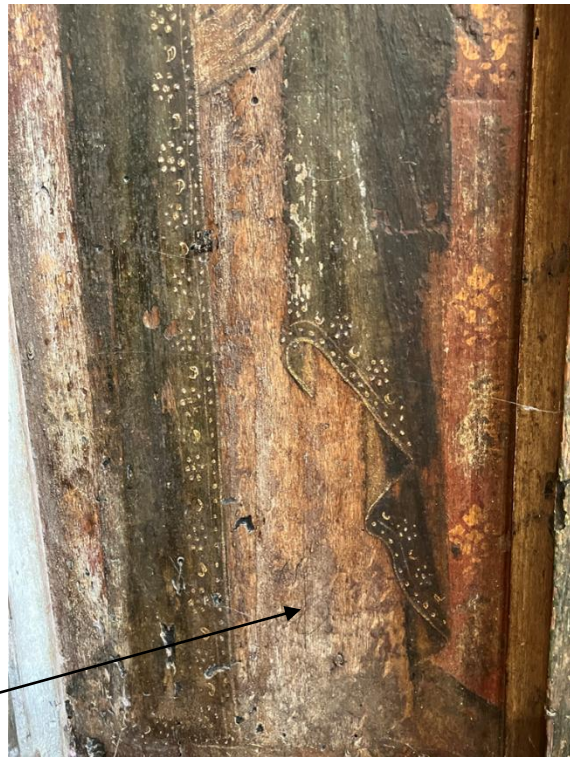
### Panel three

Discoloured varnish, blanching of the varnish.

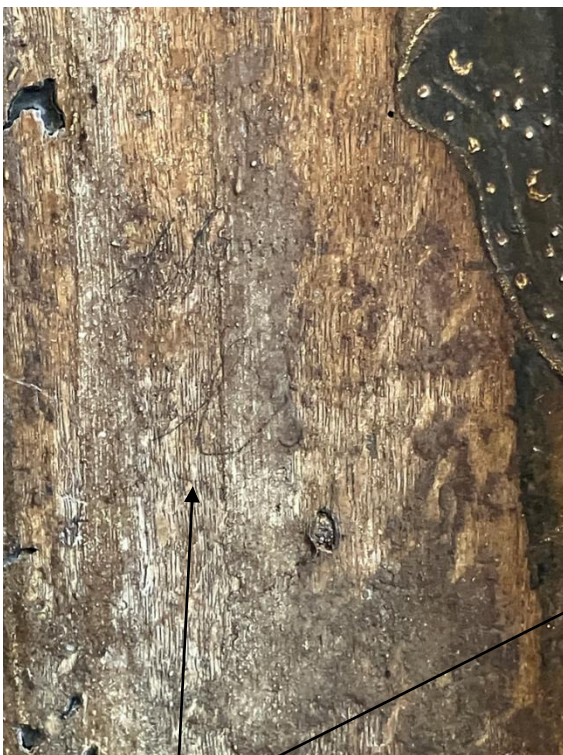
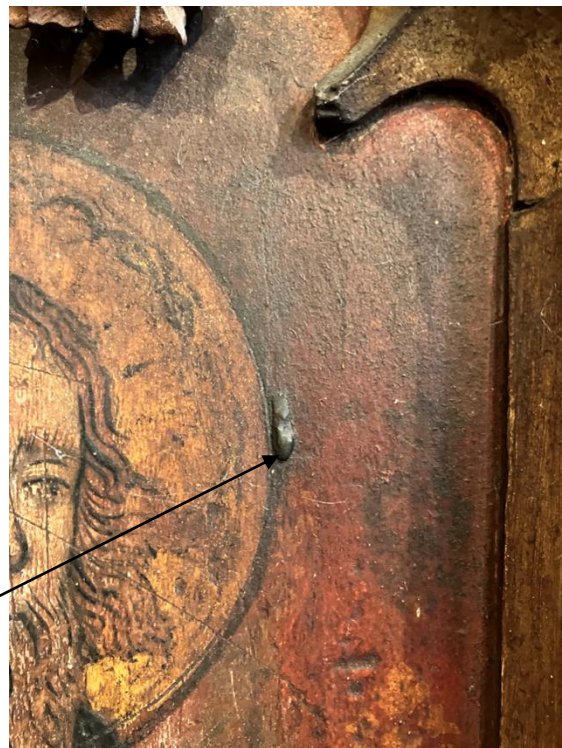
Blanched varnish, wax consolidation.

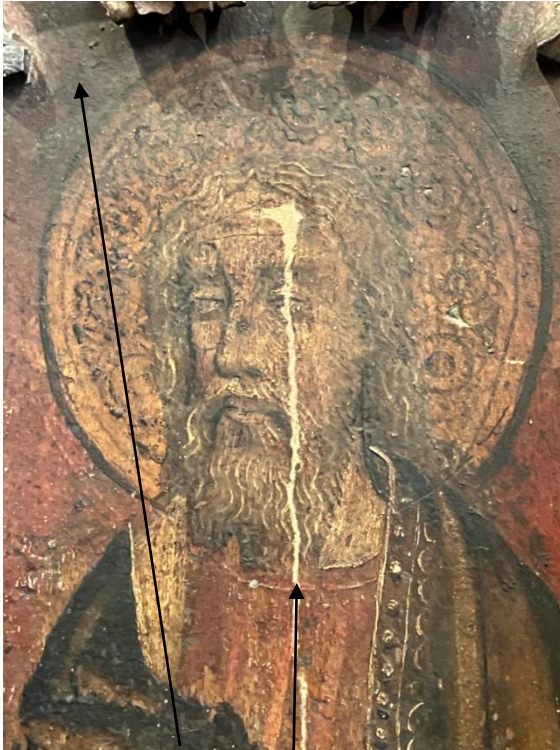
Panel four

Discoloured varnish, drip in varnish.

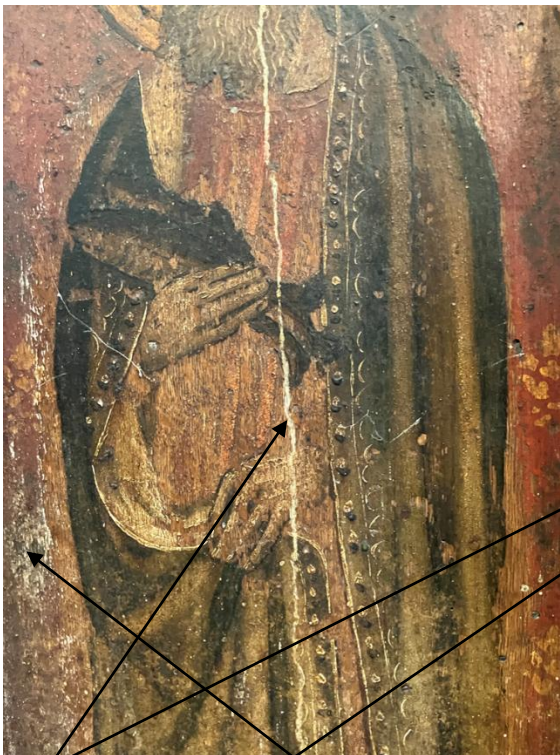
Drip in varnish, blached varnish.

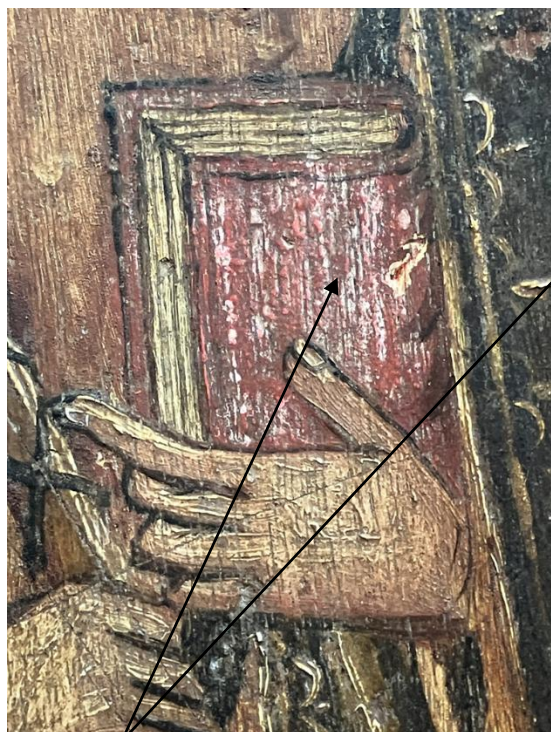
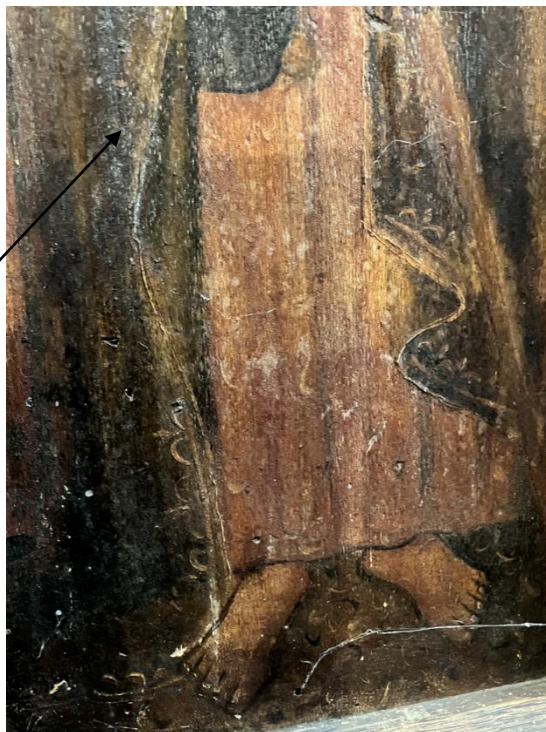
### Panel five

Blanching of the varnish.

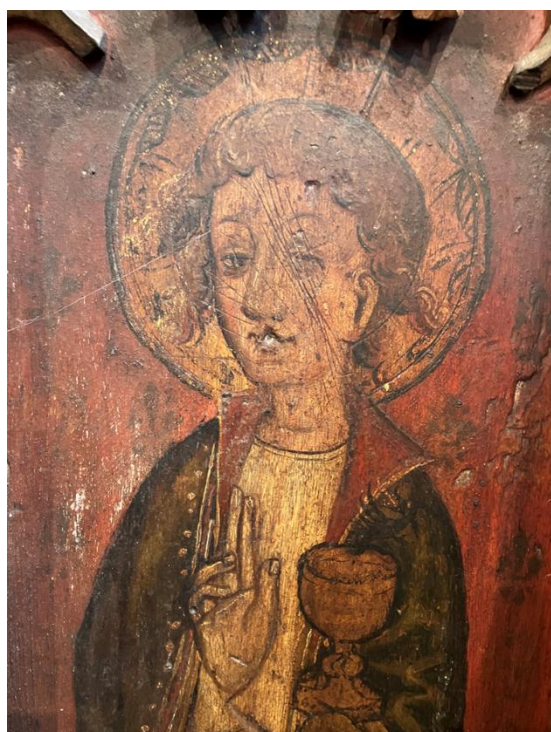
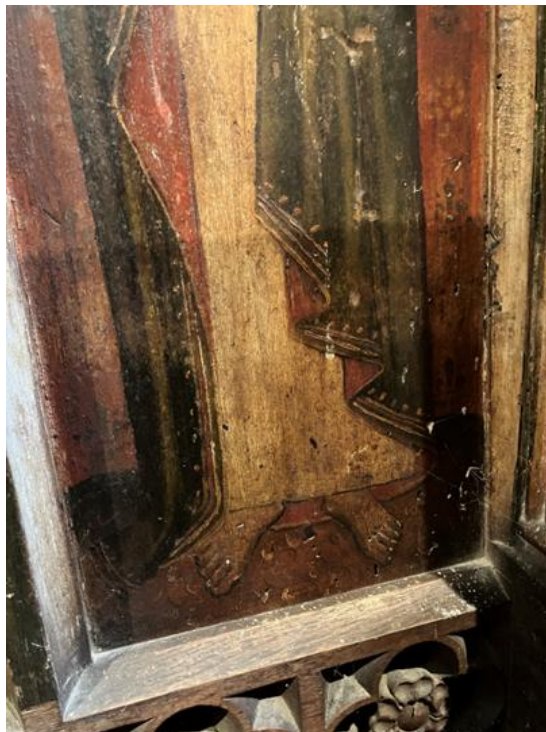
### Panel six

Discoloured varnish.

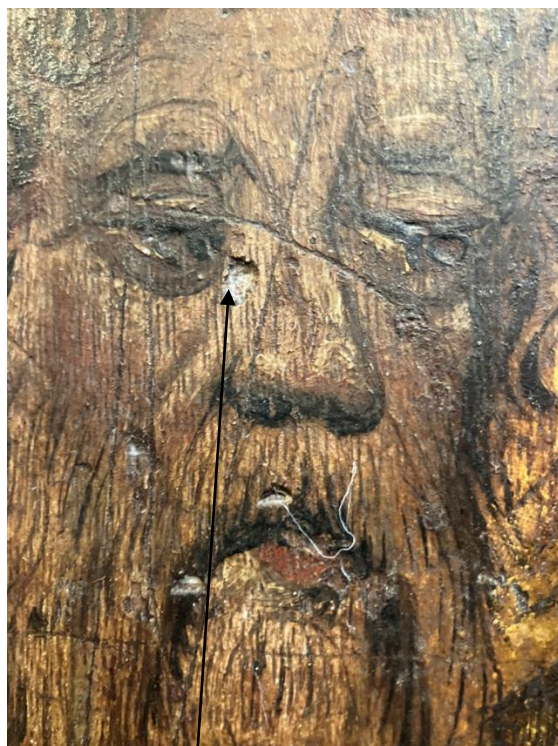
## Panel seven

Old worm damage.

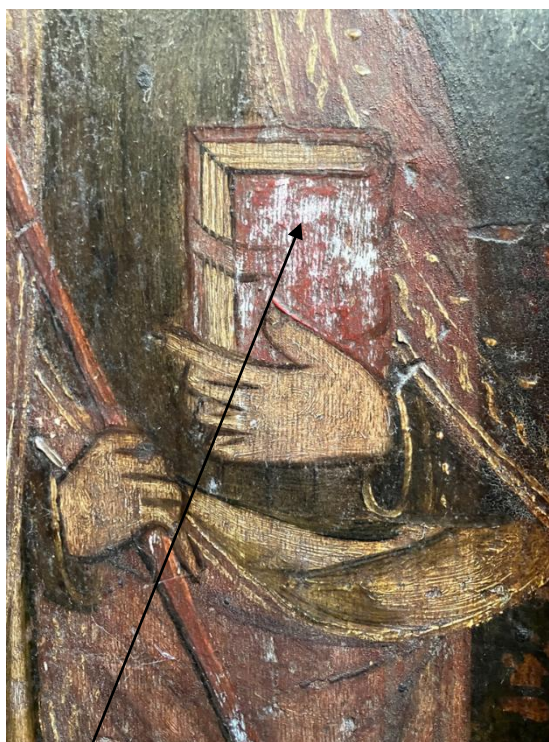
Blached varnish.

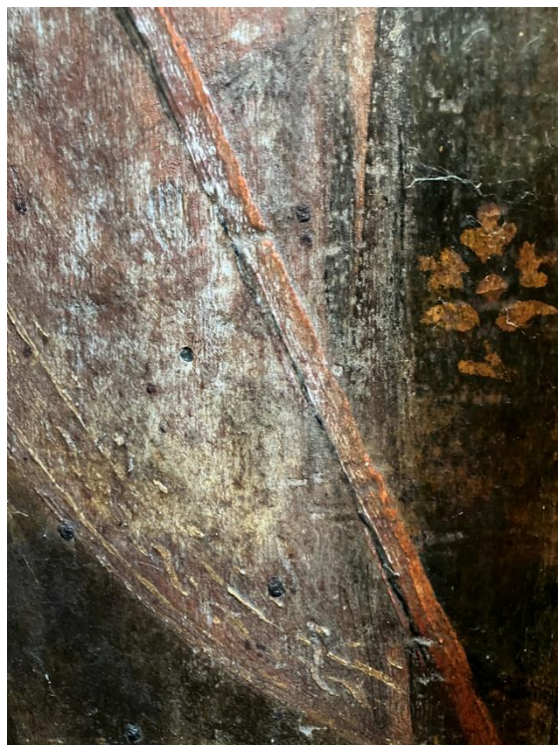
Blached varnish.

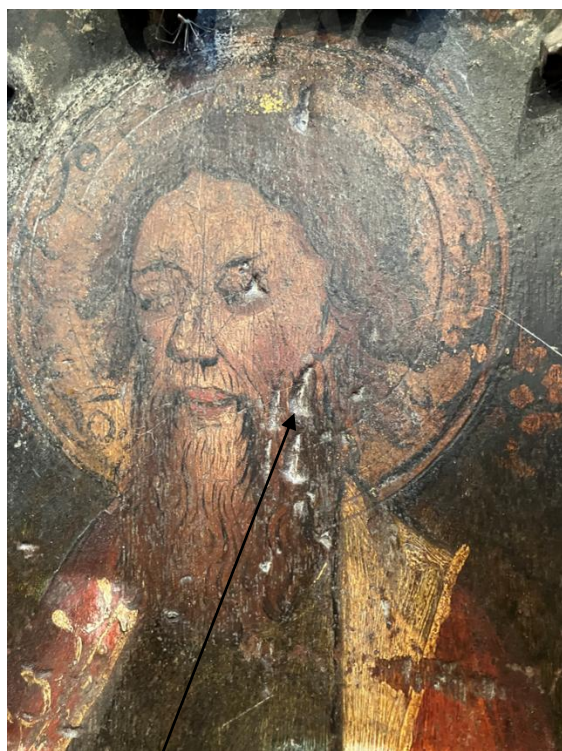
## Panel eight

Old worm damage.

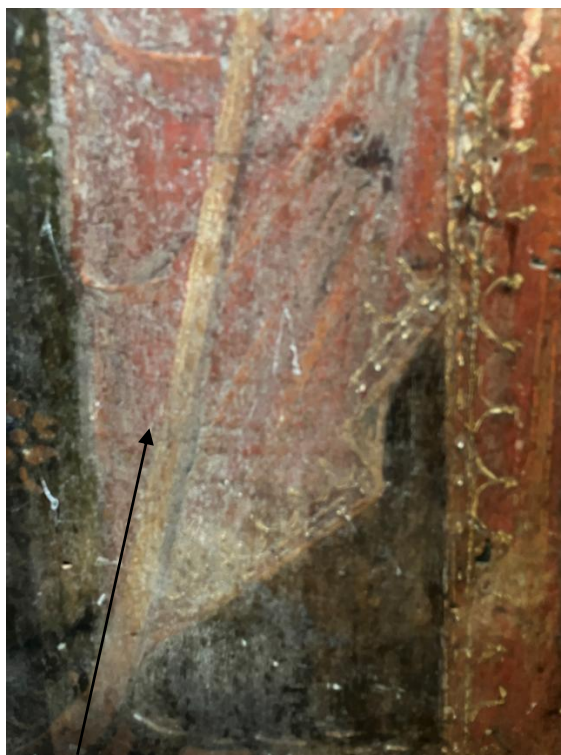
Blanched varnish.

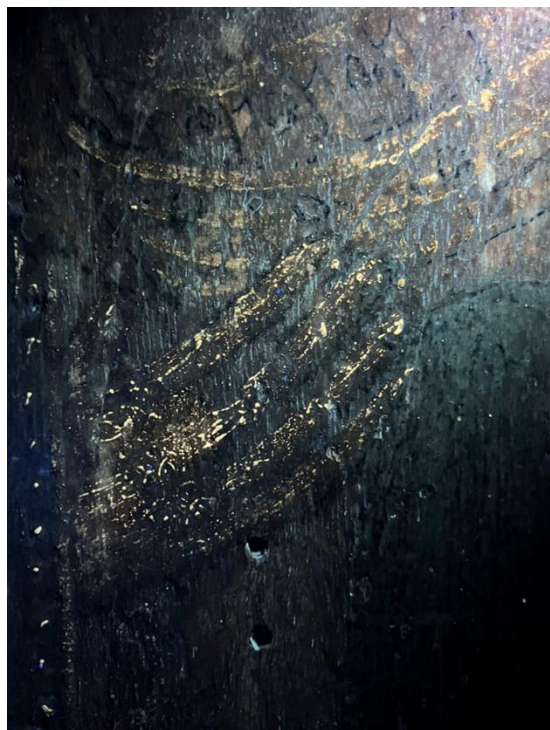
Detail under UV.  
Note blue and green fluoresce.

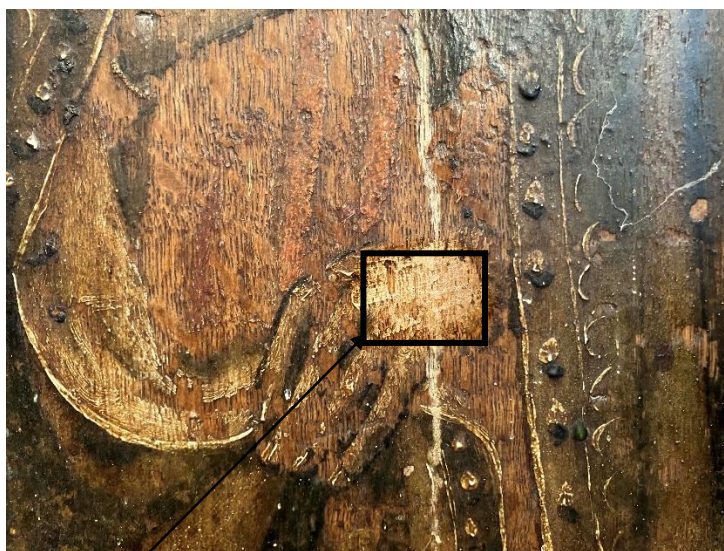
Cleaning test.
